**Re:** State Project: R-2530B  
WBS Element: 34446.1.6  
NC 24-27 from Bird Road in Albemarle to West of the Pee Dee River

**Subject: Preliminary Site Assessment**  
**Parcel #214 – Linda Goodman (Remax Properties)**  
8006 NC Hwy 73 West  
Mount Gilead, North Carolina  
F&R Project #66V-0092

## **PRELIMINARY SITE ASSESSMENT**

**Linda Goodman (Parcel #214)  
Remax Properties  
8006 NC Hwy 73 West  
Mount Gilead, North Carolina  
State Project: R-2530B  
WBS Element: 34446.1.6  
F&R Project #66V-0092**

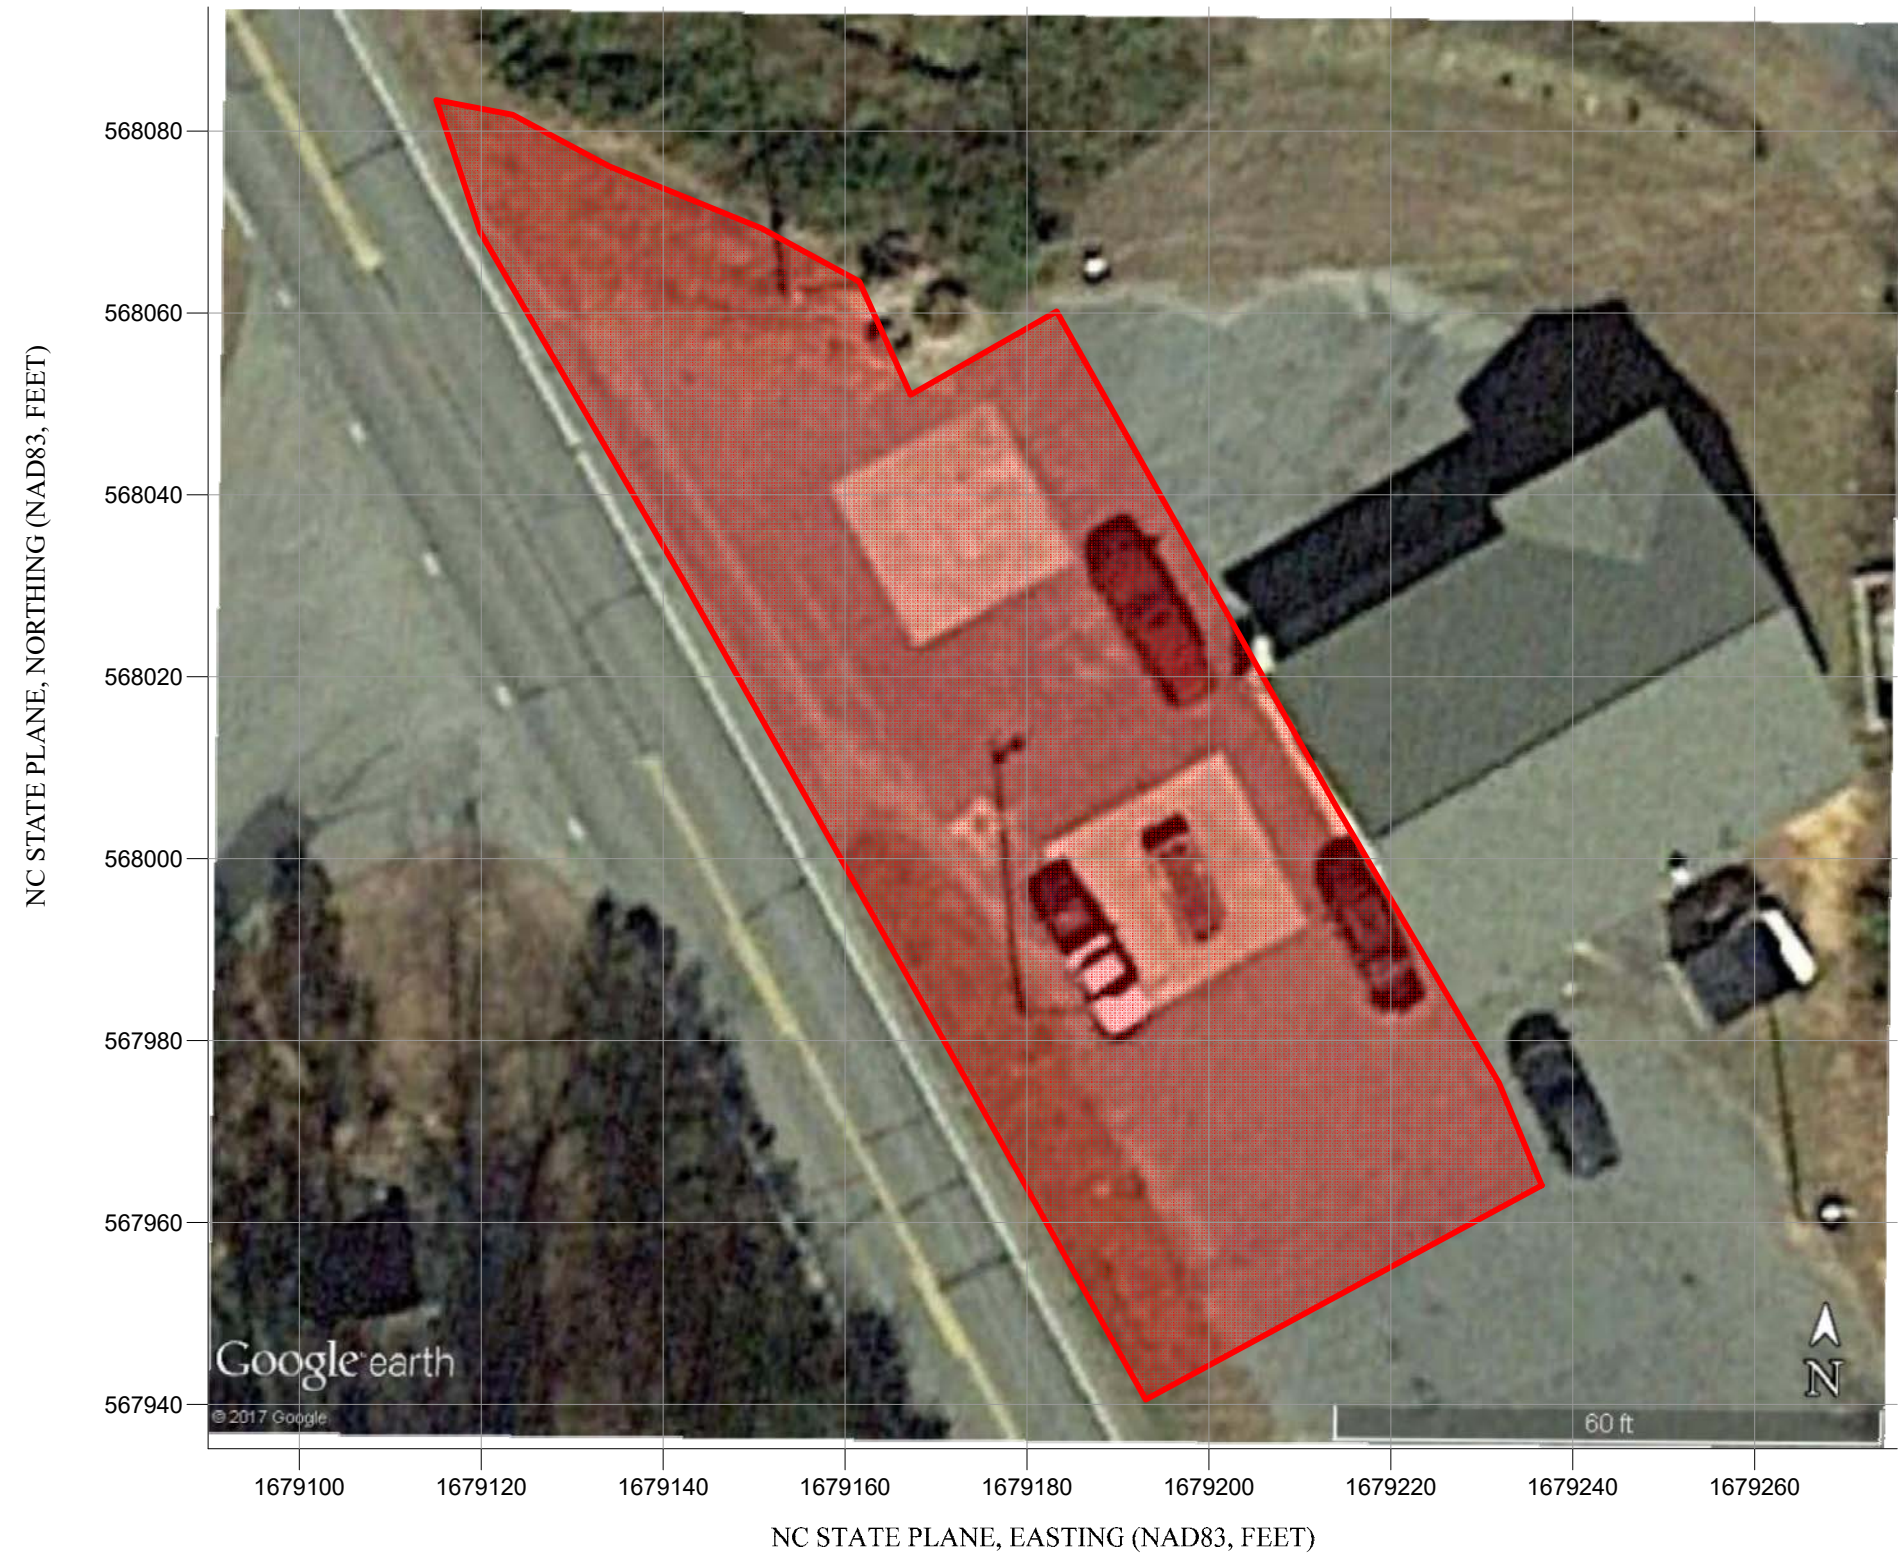
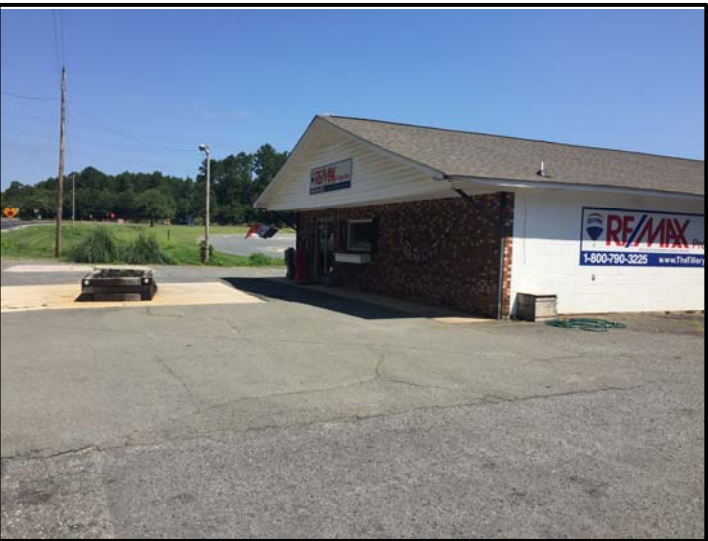
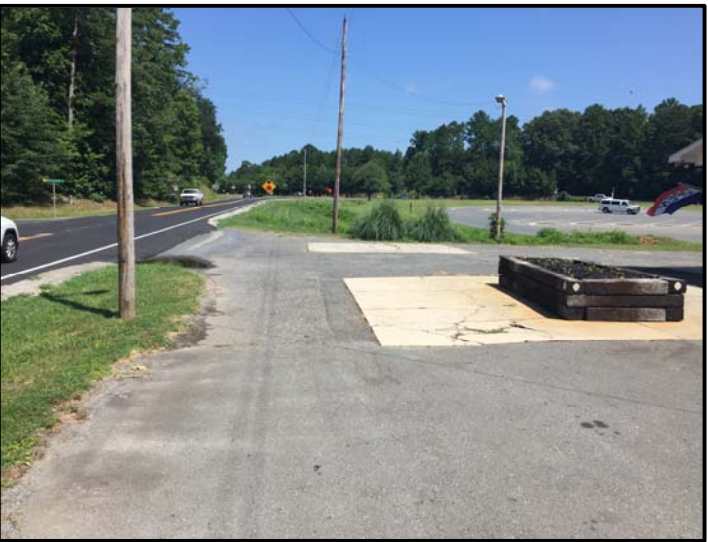
| TITLE<br>PARCEL 214 - GEOPHYSICAL SURVEY<br>BOUNDARIES AND SITE PHOTOGRAPHS | | |

The site included a commercial building surrounded by gravel parking spaces and grass areas. An aerial photograph showing the survey area boundaries and ground-level photographs are shown in **Figure 1**.

APPROXIMATE BOUNDARIES OF GEOPHYSICAL SURVEY AREA

View of Survey Area  
(Facing Approximately Northeast)

View of Survey Area  
(Facing Approximately North)

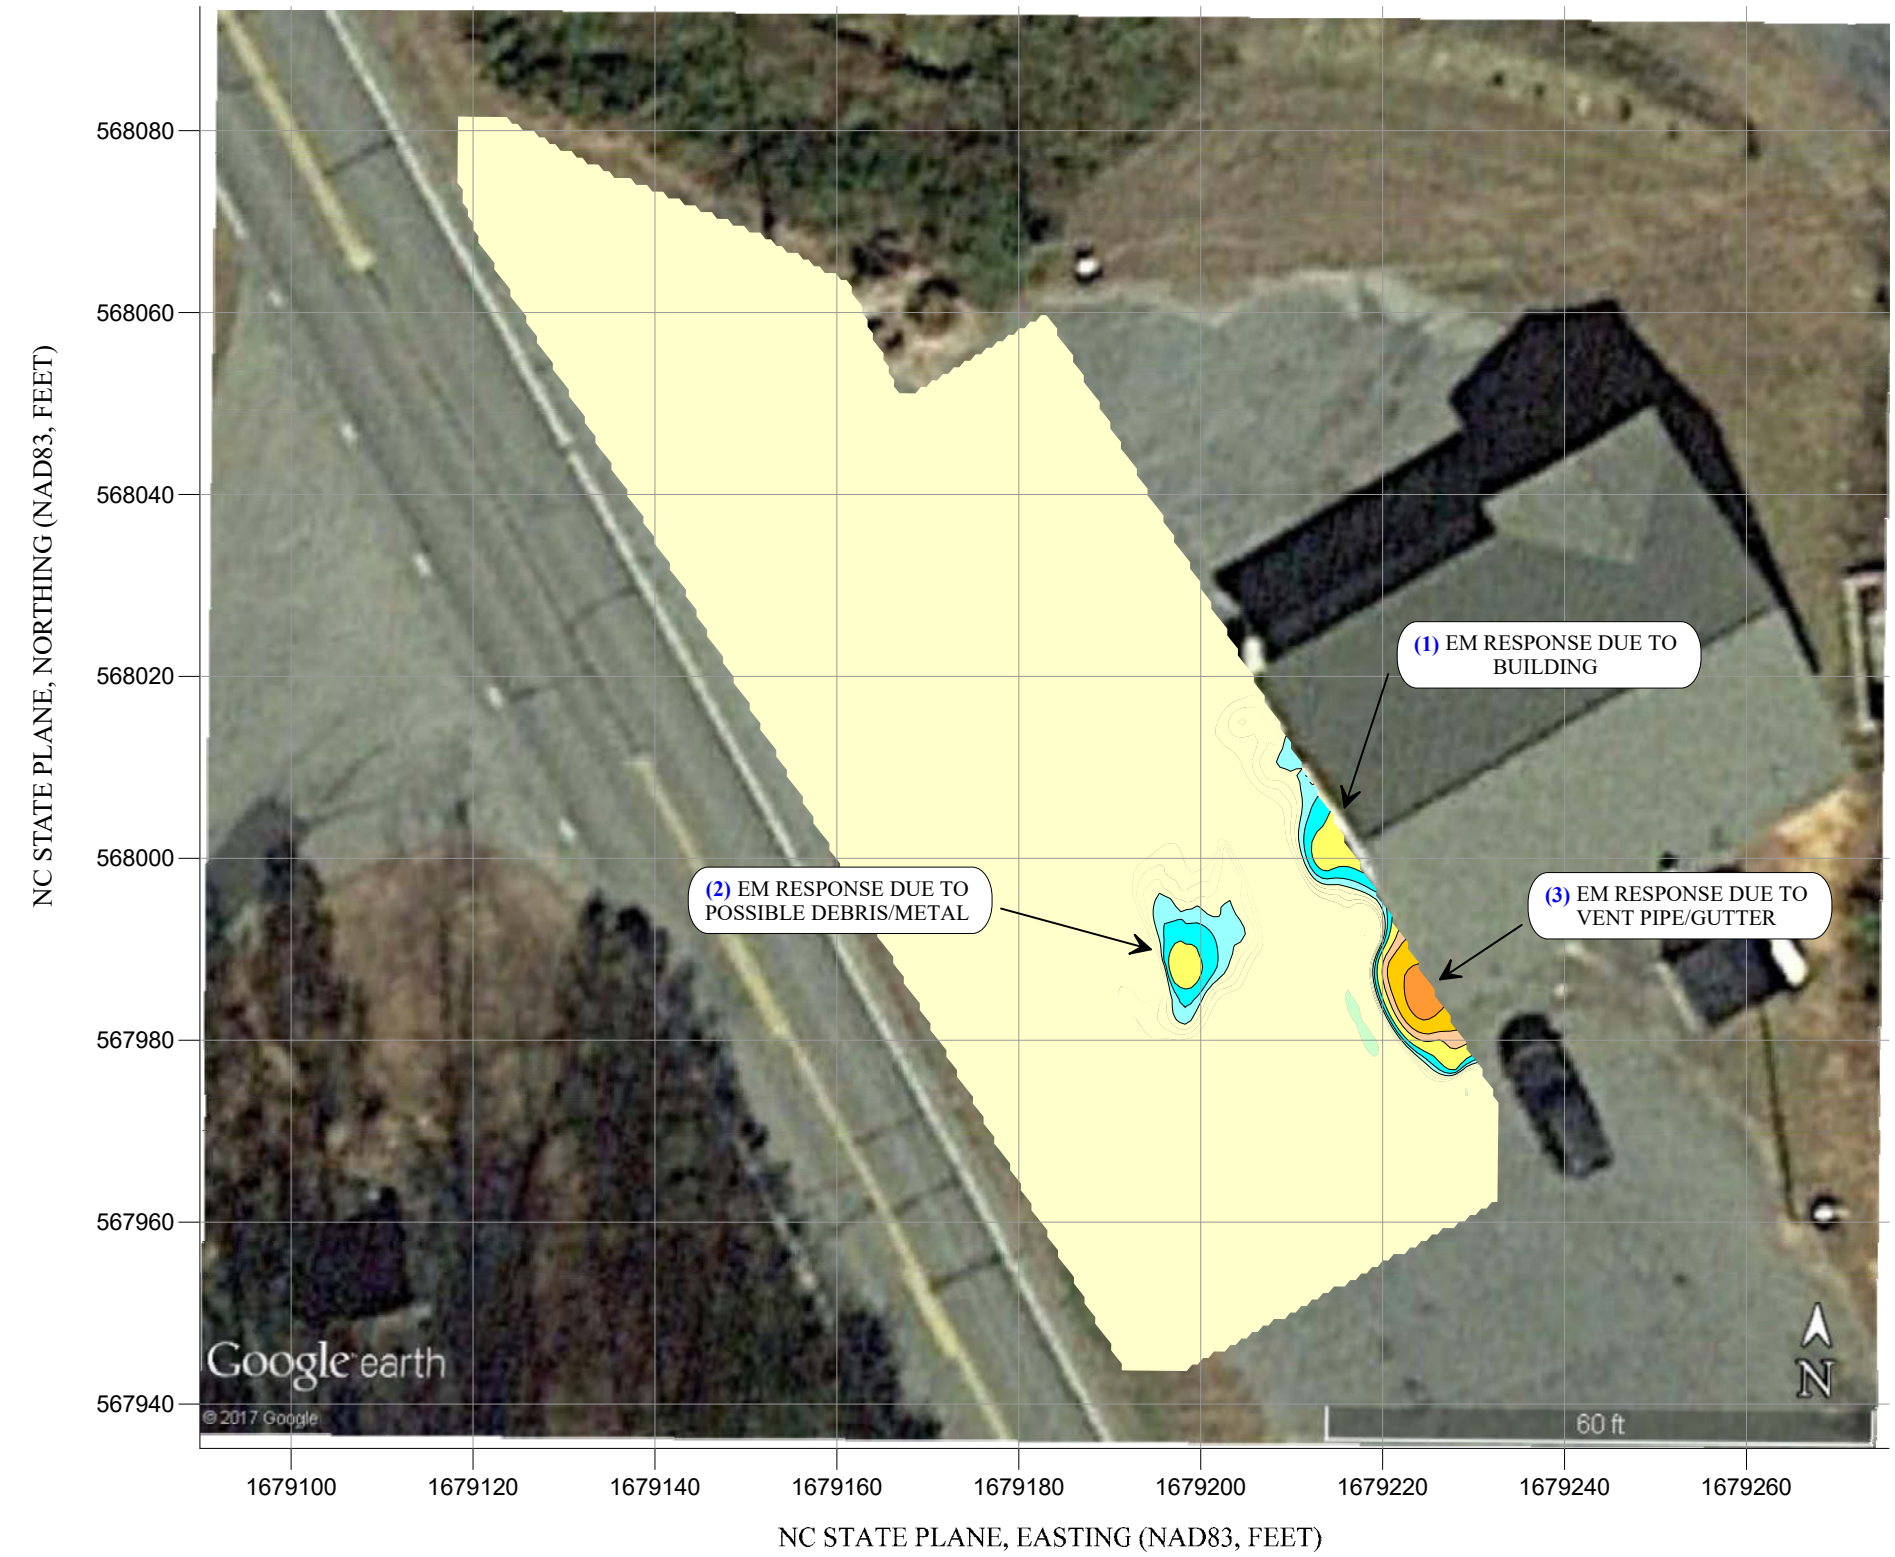
| TITLE | | PARCEL 214 -<br>EM61 RESULTS CONTOUR MAP | |

A contour plot of the EM61 results obtained across the survey area at the property is presented in **Figure 2**. Each EM anomaly is numbered for reference in the figure. The

EM Anomaly 1 was suspected to be the result of interference from the building. Anomaly 2 was associated with unknown buried metal. Anomaly 3 was suspected to be associated with a gutter and/or a former vent pipe. All areas were investigated further by GPR.

NO EVIDENCE OF UNKNOWN METALLIC USTs OBSERVED.

The contour plot shows the differential results of the EM61 instrument in millivolts (mV). The differential results focus on larger metallic objects such as USTs and drums. The EM61 data were collected on July 23, 2017, using a Geonics EM61 instrument. Verification GPR data were collected on July 25, 2017, using a GSSI UtilityScan DF unit with a dual frequency 300/800 MHz antenna.

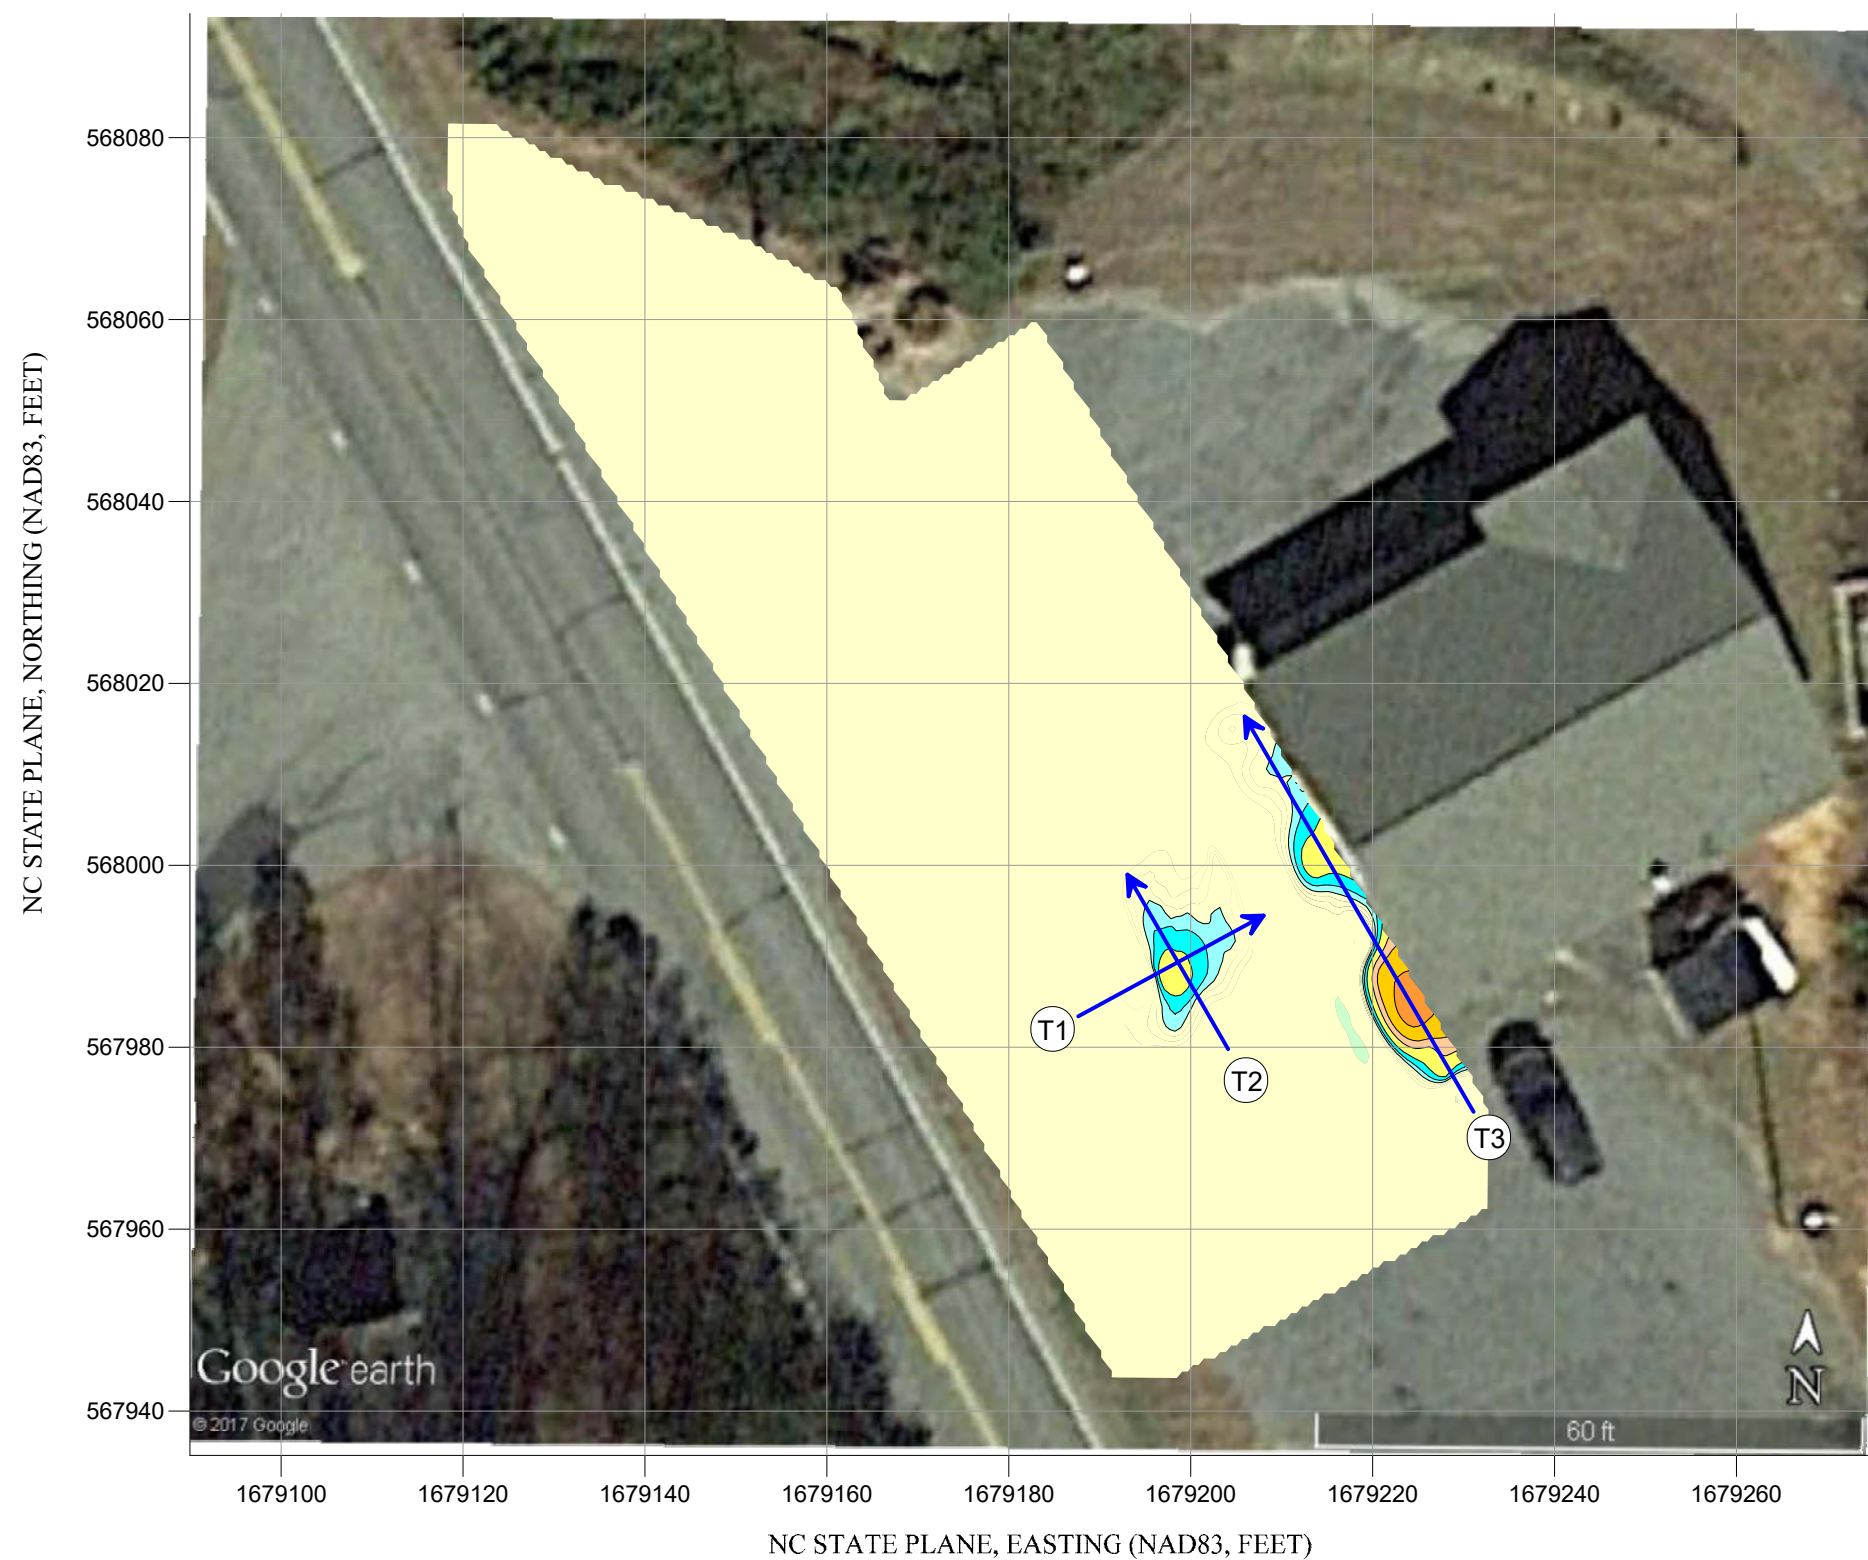
| TITLE | | PARCEL 214 -<br>GPR TRANSECT LOCATIONS<br>AND IMAGES | |

**Figure 3** presents the locations of the formal GPR transects performed at the property, as well as the transect images. A total of three formal GPR transects were performed at the site. Transects 1-2 were performed across Anomaly 2 near an apparent former pump island. These transects recorded minor reflectors that were suggestive of possible buried debris or former utilities. Transect 3 was performed parallel to the building across Anomalies 1 and 3, and also recorded minor reflectors that may be associated with debris or buried conduit.

### GPR TRANSECT LOCATIONS

GPR TRANSECT 1 (T1)

GPR TRANSECT 2 (T2)

GPR TRANSECT 3 (T3)

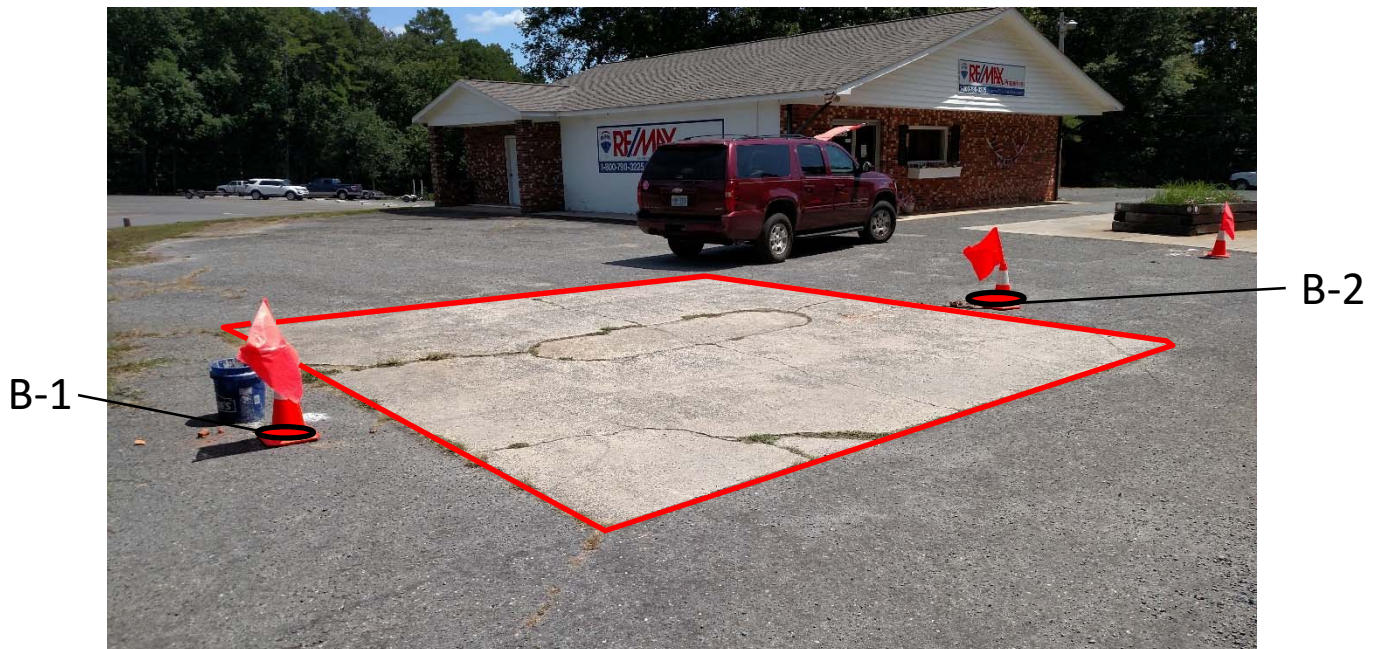
**Photo #1:** Boring locations B-1 and B-2 located just west of the on-site building, facing east.

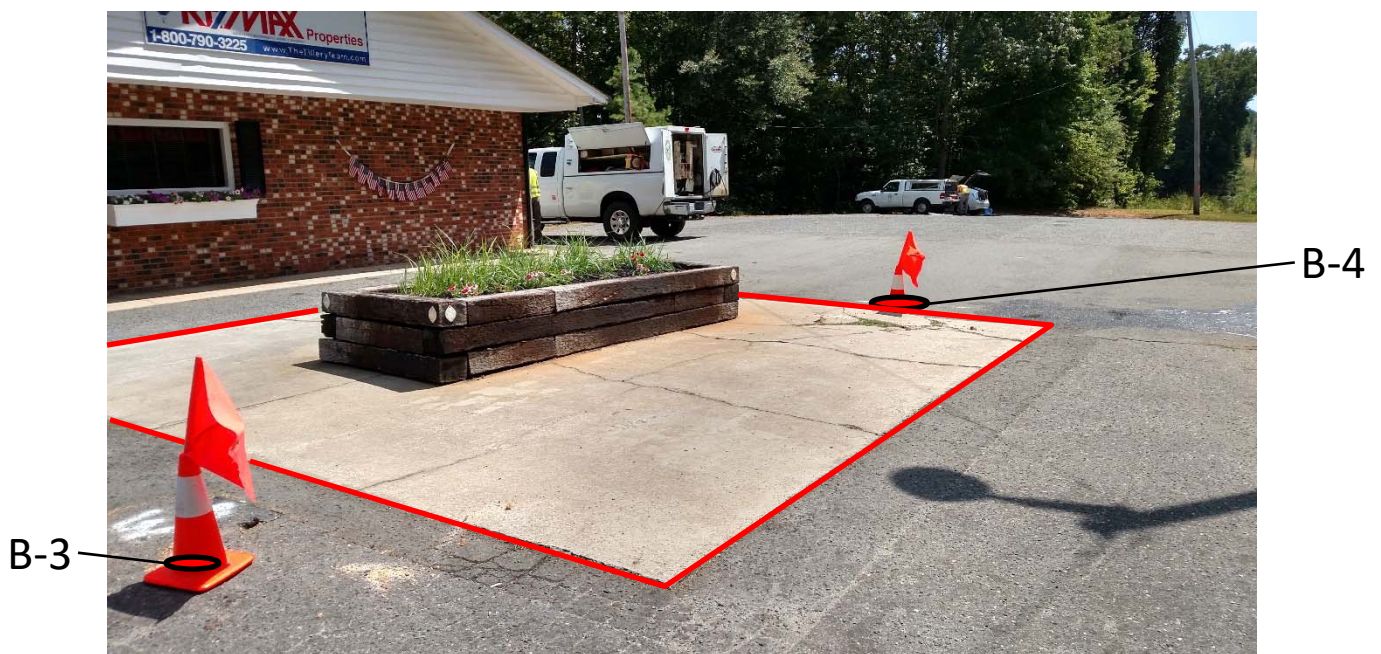
**Photo #2:** Boring location B-3, B-4, and a former fuel dispenser island located just west of the on-site building, facing east.
